# 检测报告 Test Report

Report No. A2200186258101E

| Sample Name | Pluggable terminal block |

### 3. 测试标准 Test Standard: IEC 61373-2010, Category 1-Class B

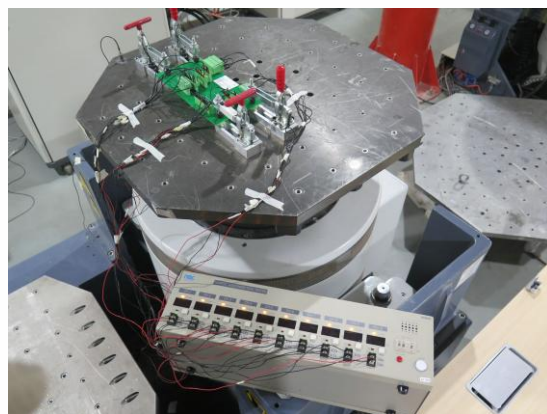
垂向 Vertical

| 样品编号<br>Sample No. | 判定依据<br>Criterion | 测试结果<br>Test Result(s) | 结论<br>Conclusion |
|---|---|---|---|
| A220018625<br>8101001 | <p>试验后产品无机械损坏，试验过程中不能出现大于 <math>1\mu s</math> 电流中断现象。</p> <p>After the test, the product has no mechanical damage, and no current interruption of more than <math>1\mu s</math> during the test.</p> | <p>测试后，目视检查样品外观无机械损伤。测试中未出现大于 <math>1\mu s</math> 电流中断现象。</p> <p>After the test, there was no visible mechanical damage on the sample by visual inspection.</p> <p>There was no current interruption of more than <math>1\mu s</math> during the test.</p> | 合格<br>Pass |

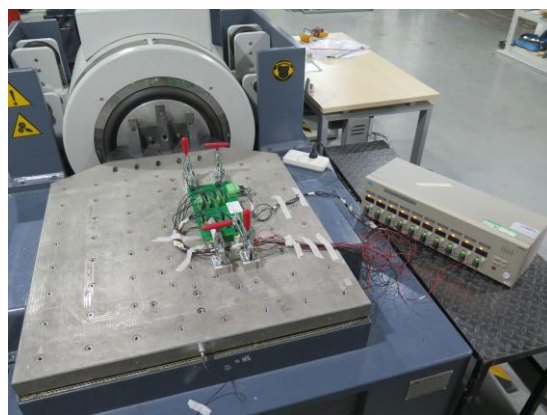
横向 Horizontal

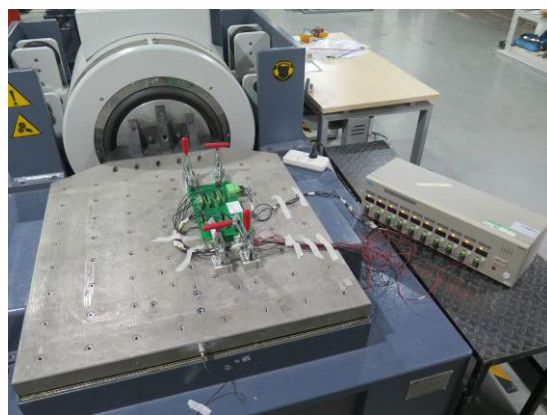
横向 Horizontal

| 样品编号<br>Sample No. | 判定依据<br>Criterion | 测试结果<br>Test Result(s) | 结论<br>Conclusion |
|---|---|---|---|
| A220018625<br>8101001 | <p>试验后产品无机械损坏，试验过程中不能出现大于 <math>1\mu s</math> 电流中断现象。</p> <p>After the test, the product has no mechanical damage, and no current interruption of more than <math>1\mu s</math> during the test.</p> | <p>测试后，目视检查样品外观无机械损伤。测试中未出现大于 <math>1\mu s</math> 电流中断现象。</p> <p>After the test, there was no visible mechanical damage on the sample by visual inspection.</p> <p>There was no current interruption of more than <math>1\mu s</math> during the test.</p> | 合格<br>Pass |
